Cottonwood Creek Fish Passage Project

Project Objective: Restore a migratory corridor for populations of native trout by upgrading an undersized and perched culvert on upper Cottonwood Creek that created a barrier to aquatic organism passage and caused channel impairments.

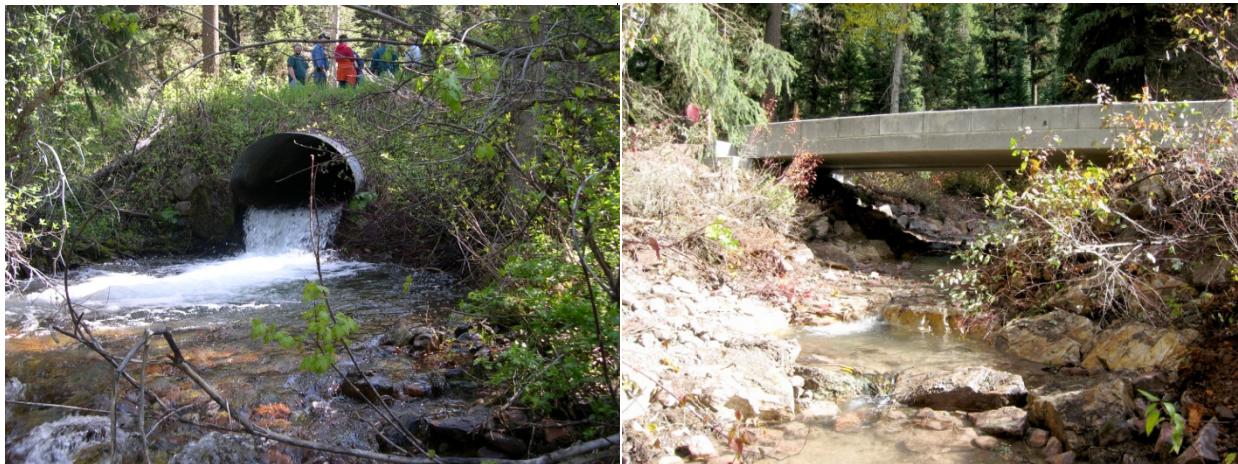
Historic undersized culvert on Cottonwood Creek near stream-mile 15.5 replaced with a free-span concrete bridge in 2007. Note the instream grade control step-pool structures post-project.

Project Details: Cottonwood Creek is a third-order tributary to the Big Blackfoot River entering near river-mile 43. The stream is a bull trout core area, designated critical bull trout habitat and supports populations of genetically pure fluvial westslope cutthroat trout. The project involved replacing a severely undersized, perched culvert at stream mile 15.5 with a concrete bridge following stream simulation guidelines and principles, allowing for aquatic organism passage, adequate hydrologic capacity for at least a 100-year flood event, and stream channel function. As the existing channel in the impacted reach had severely down-cut, we also constructed instream grade control structures to help restore and stabilize a channel gradient that allows for fish passage yet minimizes future channel adjustment and cutting. Fill slopes and stream banks were reclaimed using transplants, mulch and native grass seed.

Accomplishments: Restored fish passage to ~1.0 mile of instream habitat & corrected channel incision and erosion problems in the project area.
